# Geotechnical Evaluation Carefree Highway Improvements Cave Creek Road to Scottsdale Road Scottsdale, Arizona

April 5, 2023 | Project No. 607272001

Subject: Geotechnical Evaluation  
Carefree Highway Improvements  
Cave Creek Road to Scottsdale Road  
Scottsdale, Arizona

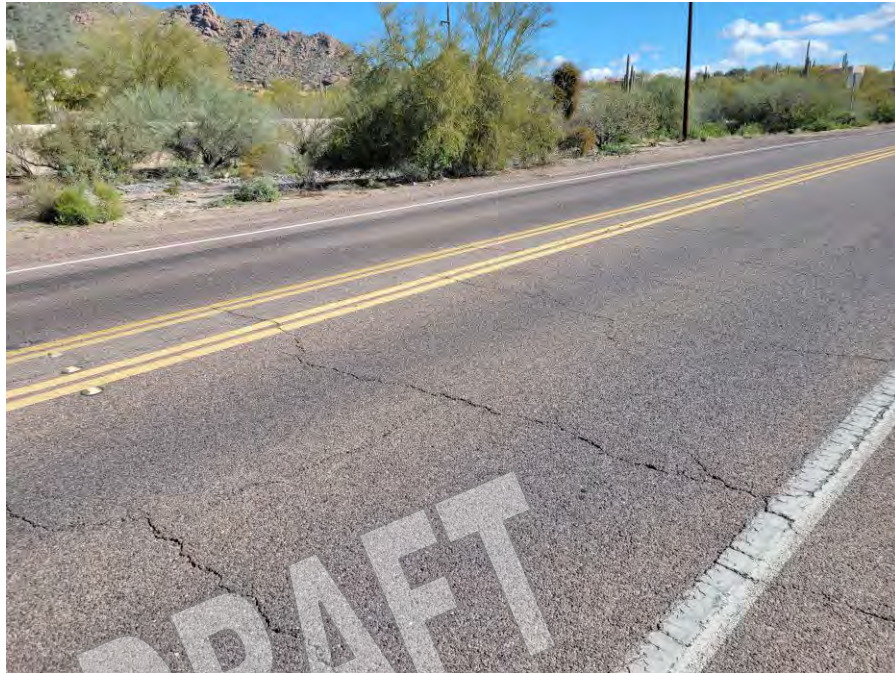
**Photograph 1:** Typical block cracking.

- Medium to high severity block cracking was observed along much of the roadway.
- Medium to high severity alligator cracking was observed, mainly in areas where natural washes crossed the roadway. These areas typically had poor drainage which allow water to pool after storm events.
- Medium severity patching due to repairs or utility installation were prevalent along much of the roadway.
- Potholes and areas where delamination of previous AC overlays were observed in isolated areas along the roadway.

In general, the distresses seem to be a combination of aging AC pavement, increased traffic loading, poor draining and/or poor subgrade conditions. Select photographs are provided in Appendix A.

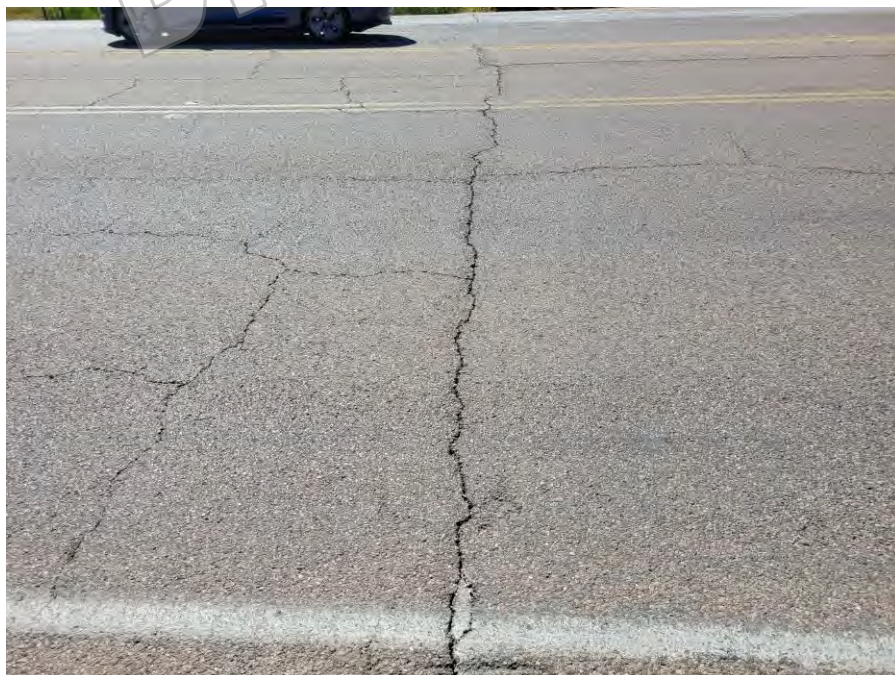
**Photograph 2:** Typical block cracking.

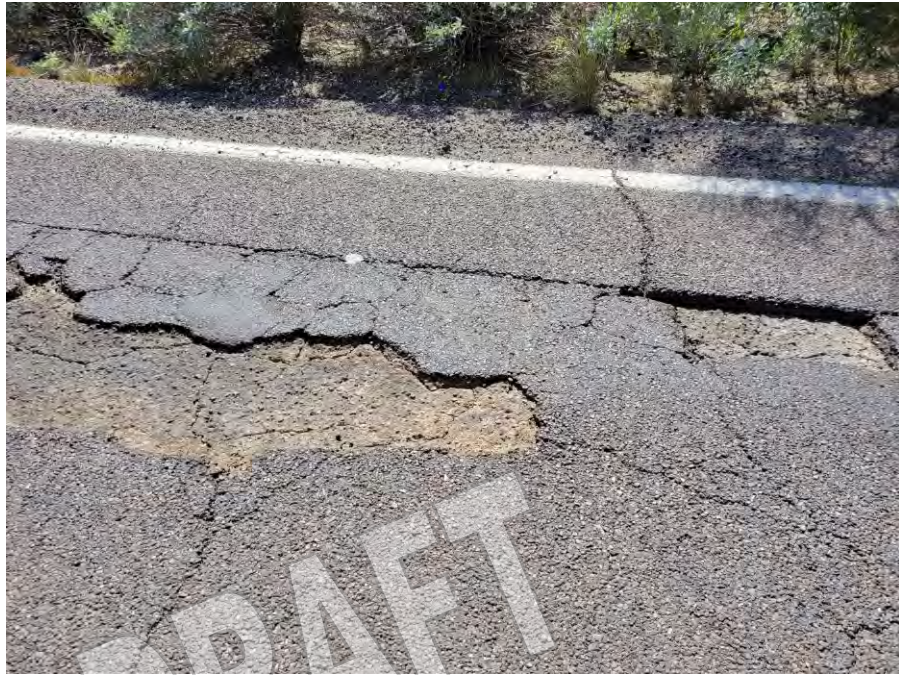
**Photograph 3: Example of delamination of previous overlay**

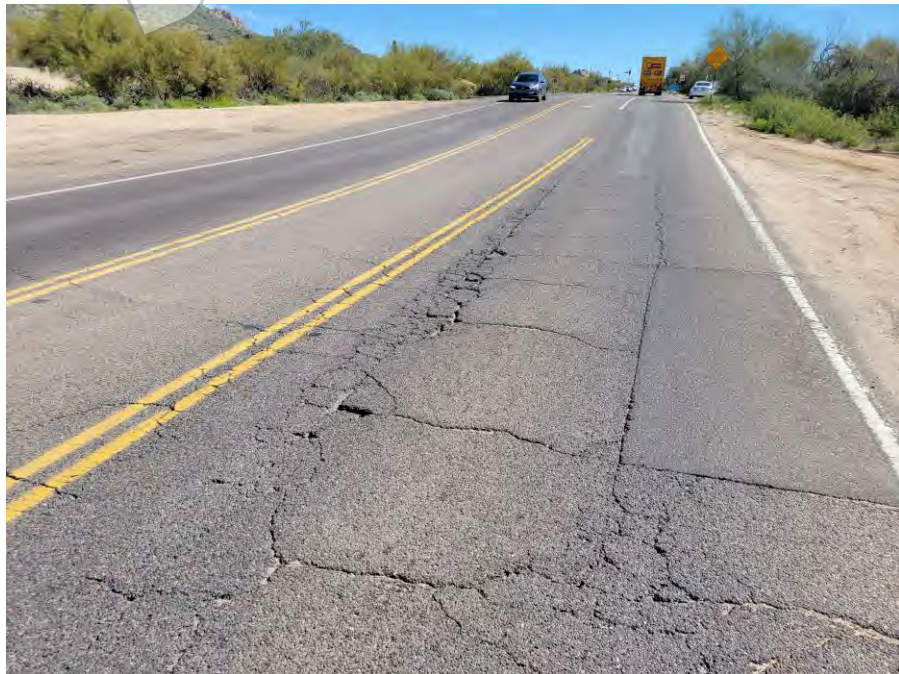
**Photograph 4: Example of alligator cracking and patch in poor drainage area.**

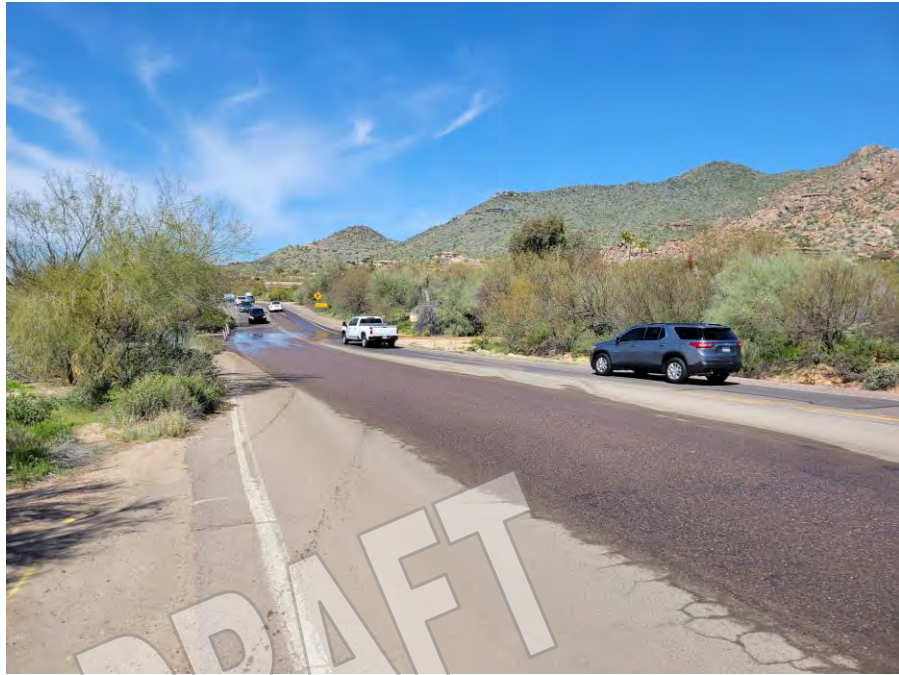
**Photograph 5:** Example of poor drainage.

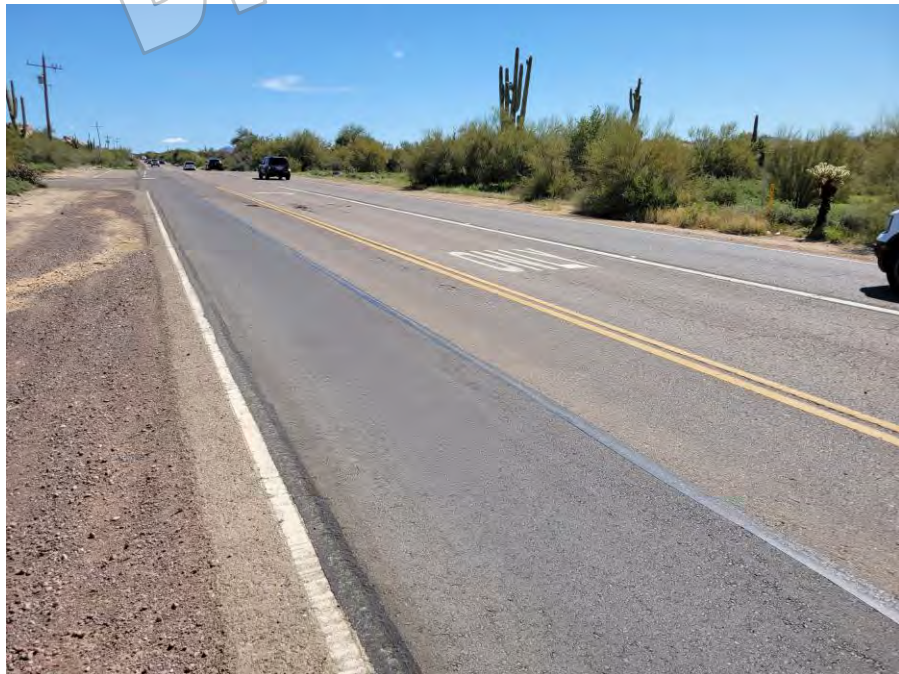
**Photograph 6:** Example of utility trench patch.

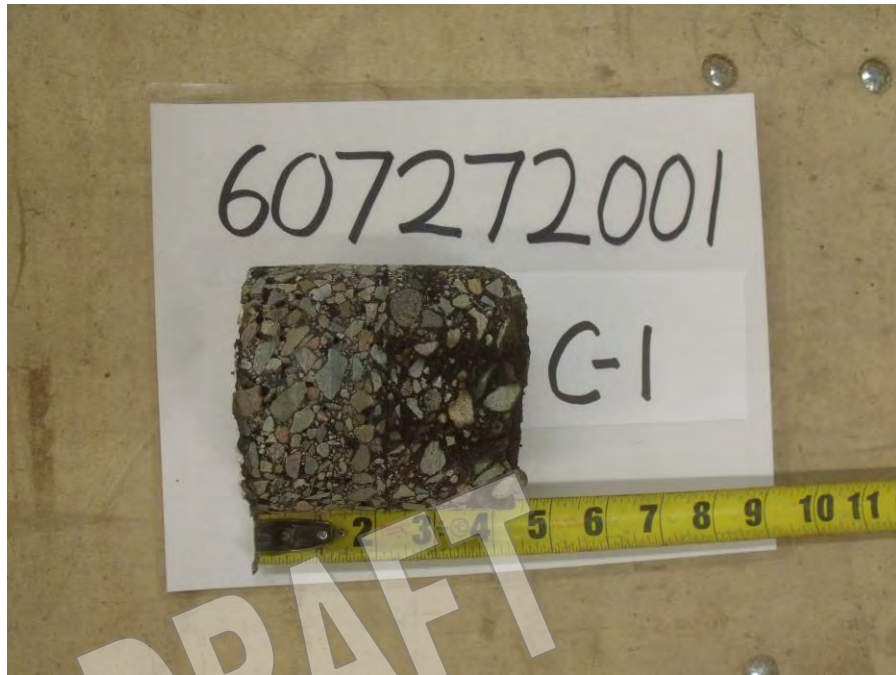
**Photograph 7:** Core Location C-1, asphaltic concrete thickness approximately 4.5 inches. Approximately 6 inches of aggregate base at C-1

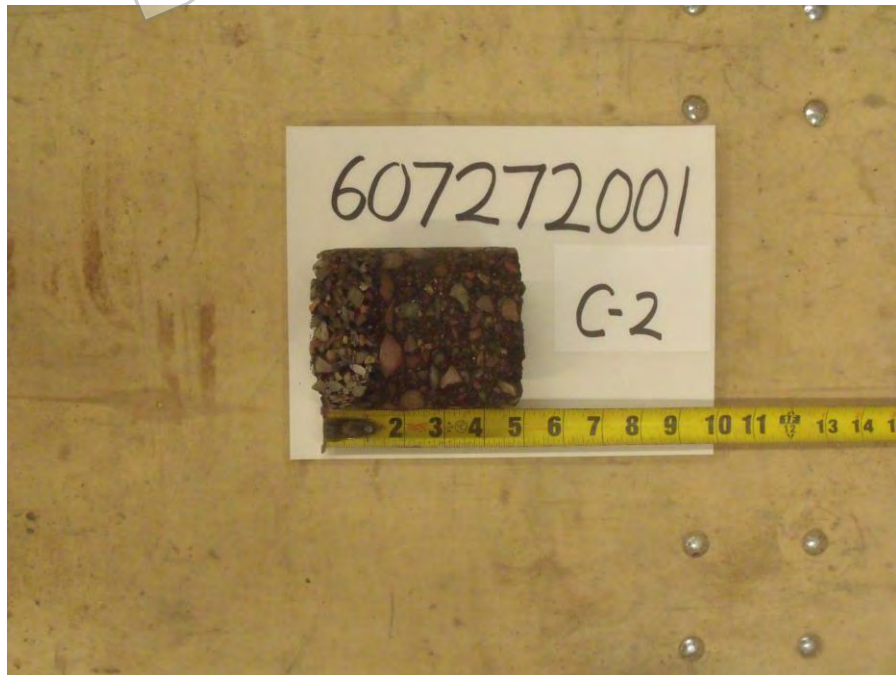
**Photograph 8:** Core Location C-2, asphaltic concrete thickness approximately 5 inches. Approximately 6.5 inches of aggregate base at C-2.

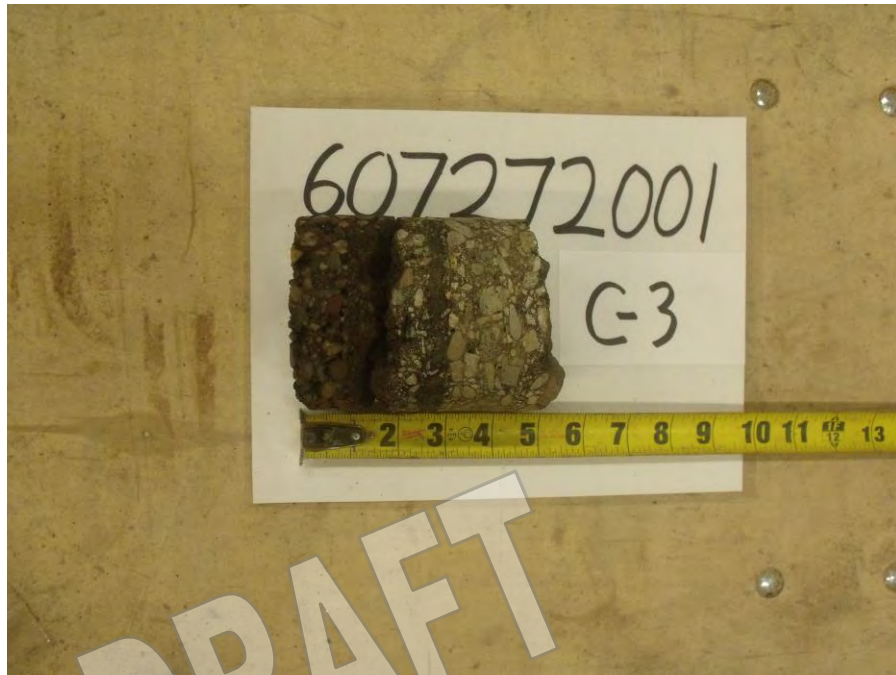
**Photograph 9:** Core Location C-3, asphaltic concrete thickness approximately 5 inches. Approximately 9 inches of aggregate base at C-3.

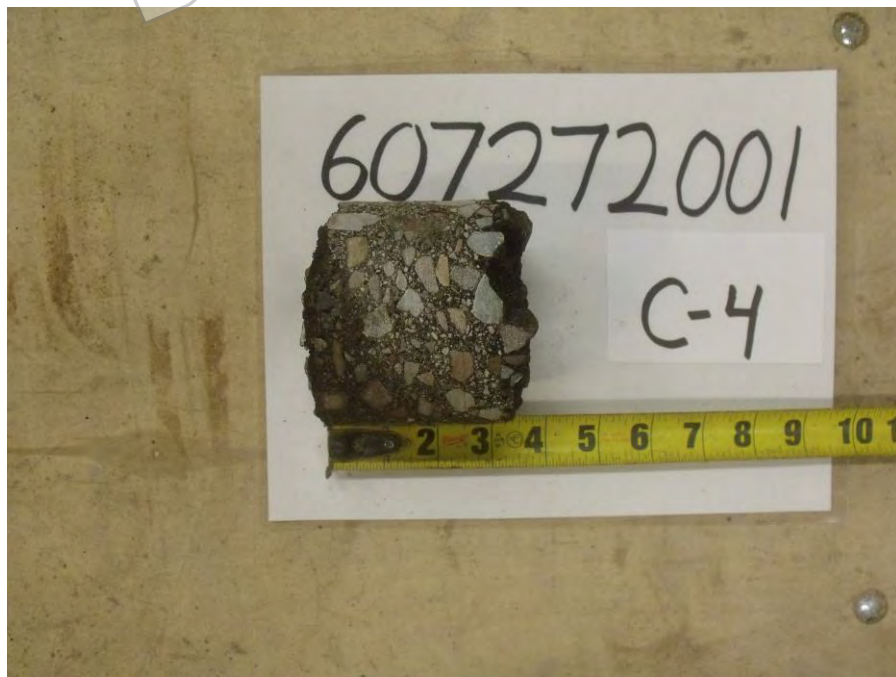
**Photograph 10:** Core Location C-4, asphaltic concrete thickness approximately 3.5 inches. Approximately 7.5 inches of aggregate base at C-4

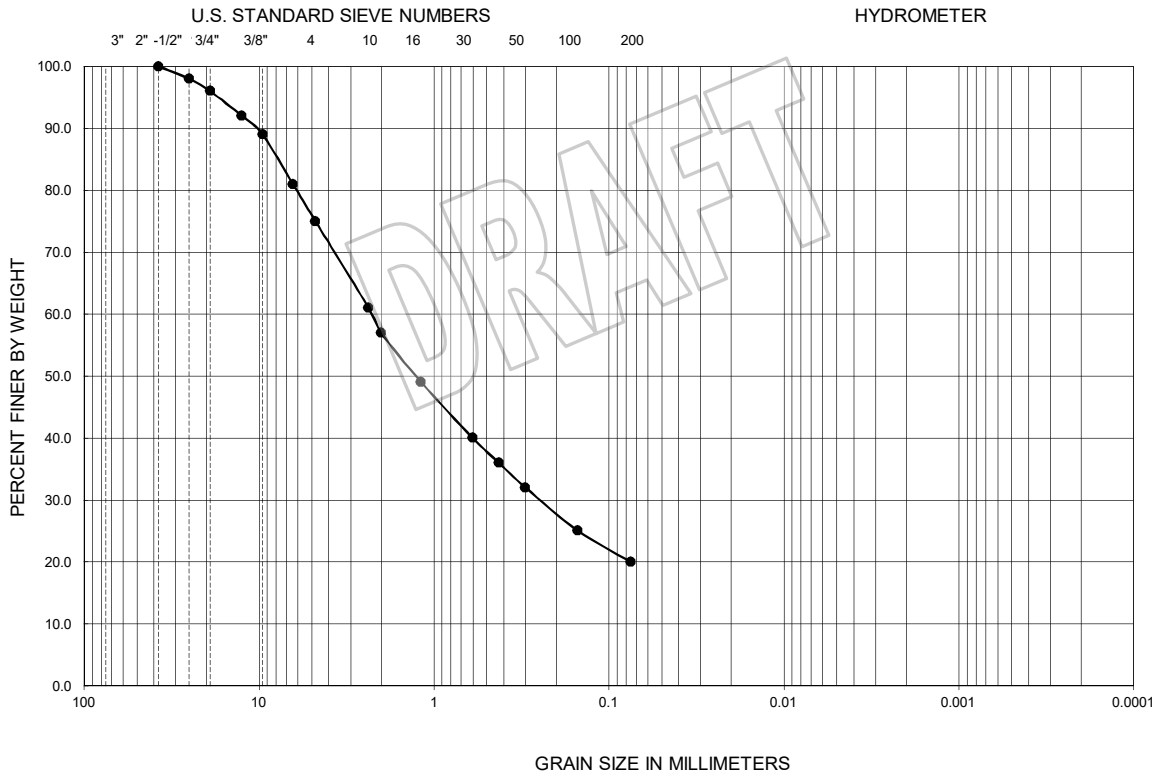
Symbol	Sample Location	Depth (ft)	Liquid Limit	Plastic Limit	Plasticity Index	D <sub>10</sub>	D <sub>30</sub>	D <sub>60</sub>	C <sub>u</sub>	C <sub>c</sub>	Passing No. 200 (percent)	USCS
●	B-7	0.0-5.0	26	14	12	--	0.249	2.29	--	--	20.0	SC

PERFORMED IN GENERAL ACCORDANCE WITH ASTM C136 / D422
