Potential Improvements

REACH 3 SOUTH

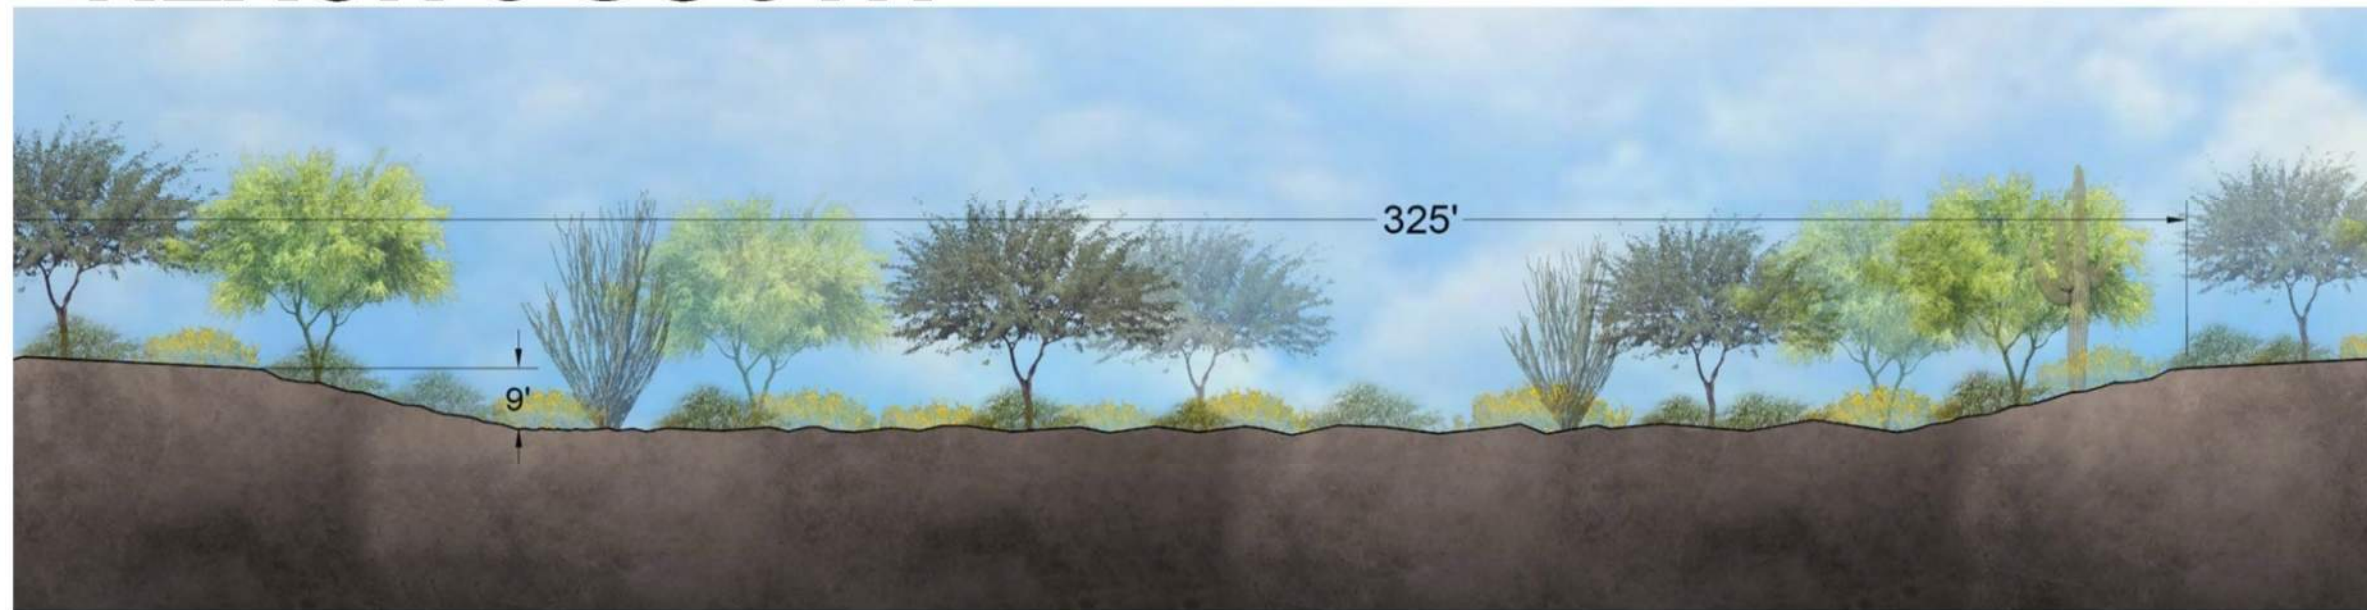
EXISTING EARTHEN CHANNEL

- Minor improvements to existing bank protection and levees needed in some locations to meet FEMA criteria
- Additional field investigation required to verify
